# Terrestrial Laser Scanning and Settled Techniques: a Support to Detect Pathologies and Safety Conditions of Timber Structures

**Keywords:** Cultural Heritage, Wood dome, Structural assessment, Digital Photogrammetry, Laser survey, Orthophoto.

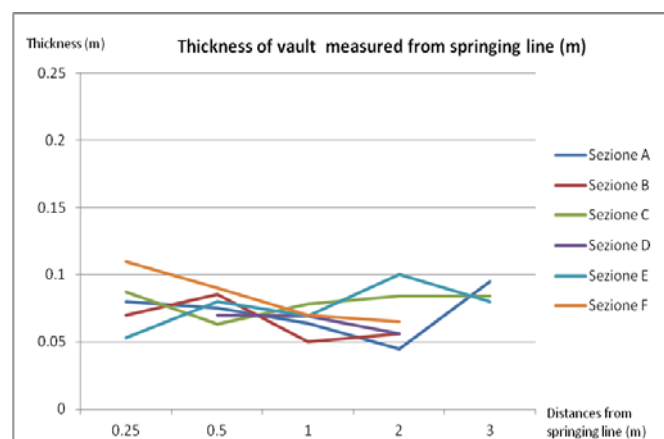
Figure 6: The thickness has been measured along some radiuses, interpolating arcs derived from Delorme geometrical scheme. Some sample vertical sections (A, B, C, D, E, F, about 1.5 m distant from each other) have been located in the measurable portion of

upper model, and they have been inspected and measured.

The maximum thickness is 0.22 m at the springing line. At the range distance between 0.5 m to 1m in plan from the walls, the average thickness decreases and becomes rather equal to 0.10 m. At the reins the thickness is minimum, and rather equal to only 0.06 m. In the central part of the dome the thickness is about 0.11 m, probably due to restorations and material additions. (Fig. 6-7)
